# 2017 ASPECT Preliminary Report Arkema Plant Response, Crosby, TX

Rapids Needs Assessment

September 1, 2017 0500 hrs to 1800 hrs

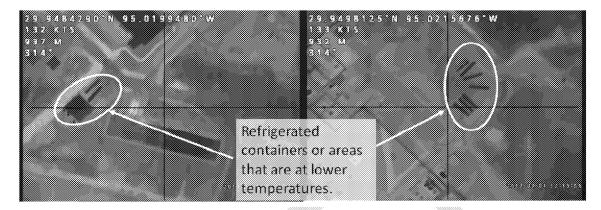
0720 hrs: ASPECT made numerous passes over the facility and there were no significant chemical detections. The crew reported that the IR video showed that the trailers are cool. See Figure 2.

Figure 2: Infrared images obtained from an infrared video (0615 hrs CST) clearly show that the containers are being cooled (black colors) at the Arkema facility.

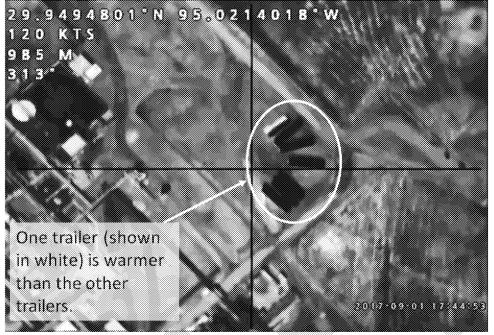
1240 hrs: ASPECT made numerous passes over the facility and there were several detections about 50 m downwind from the facility (wind direction was coming from 350 degrees with wind speeds less than 2 m/s) showing weak (e.g., slightly above the 5.3 ppm detection limit) signatures consistent with peroxide. Figure 4 is an image from the infrared video which indicates that the northernmost trailer looks warmer than the surrounding trailers. Figure 5 is an image of an oblique photo taken on 30 August of the trailers shown in Figure 4.

Figure 4: Image taken from the infrared video showing that one trailer looks warmer (e.g., colored white) than the surrounding trailers. The time stamp is UTC time; local time is 6 hours behind (1144 hrs CST).

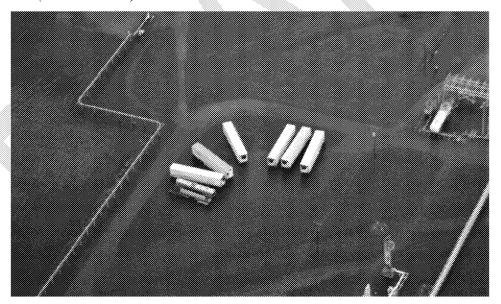
Figure 5: Oblique photo taken on 30 August 2017 of the trailers shown in Figure 4.

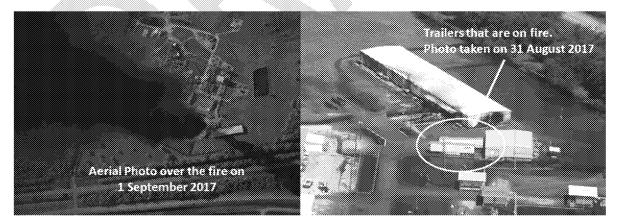
- 1640 hrs: Roberto Bernier, R6 OSC, called Mark Thomas and reported that white smoke was rising from several trailers at the Arkamen site. The crew is preparing to respond to conduct chemical monitoring and collect aerial photographs.
- 1710 hrs: ASPECT was airborne and arrived on site by 1725 hrs. Initial reports from the crew reported a yellow plume rising to 3,000 ft AGL. The crew increased altitude to 4,000 ft AGL to take aerial and oblique photos as well as conducting chemical sweeps over the site. Figure 6 shows the plume coming from the trailer(s) which were on fire. The image to right is an oblique image taken from the aircraft on 31 August 2017.

Figure 6: Thumbnail image (left, very low resolution) taken from the aircraft during the response. Oblique image showing the trailers that eventually caught fire.

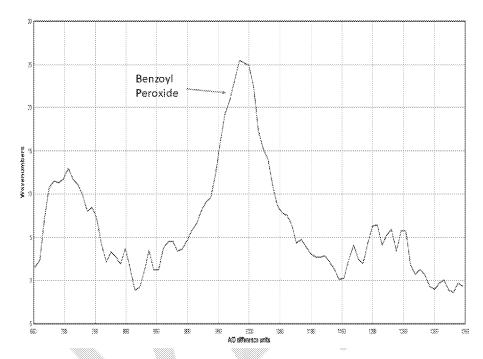
1815 hrs: The aircraft remained on station, making 19 passes over the fire to continue monitoring and collect photos. Figure 8 illustrates the spectral characteristics of a typical hot fire. The primary constituents observed in this spectra are ozone, benzoyl peroxide, trace quantities of hot carbon dioxide and possibly small amounts of 1-butene (combustion products).

Figure 9: Image of the FTIR spectra collected over the fire. Primary constituents observed in this spectra are ozone, benzoyl peroxide, trace quantities of hot carbon dioxide and possibly small amounts of 1-butene (combustion products).
